# Mākaha Valley Flood Mitigation Study

PUBLIC REVIEW DRAFT- APPENDICES  
AUGUST 2014

Volume II of III

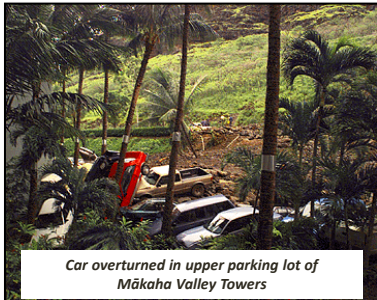
*Car overturned in upper parking lot of  
Mākaha Valley Towers*

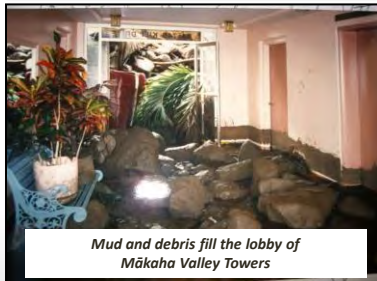
*Mud and debris fill the lobby of  
Mākaha Valley Towers*

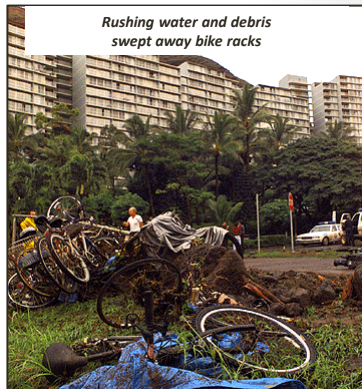
*Rushing water and debris  
swept away bike racks*

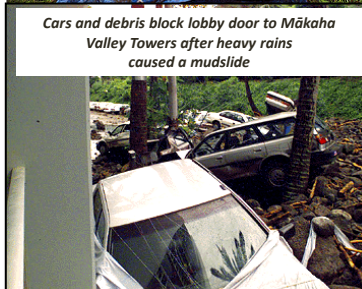
*Cars and debris block lobby door to Mākaha  
Valley Towers after heavy rains  
caused a mudslide*

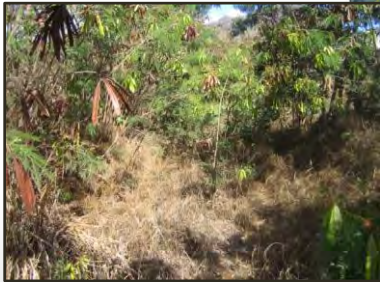
Overgrown vegetation in Eku Stream

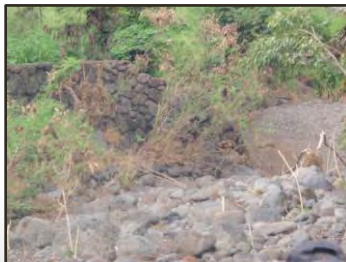
Damaged water berm wall in lower Mākaha

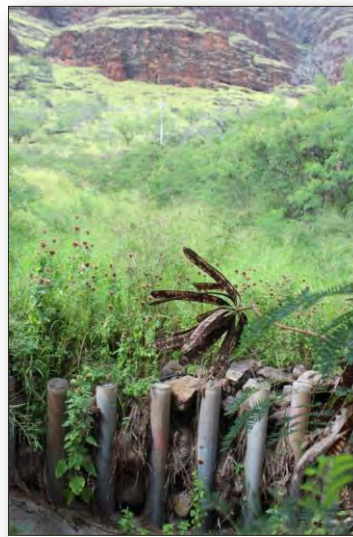
*Rocks filled to the top of the debris poles*

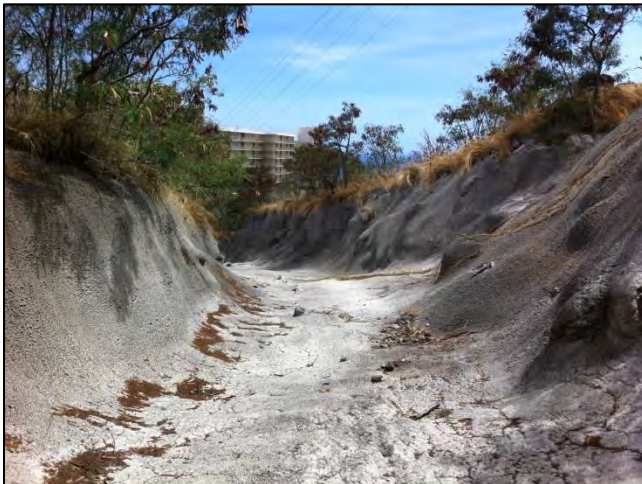
**CONCRETE-LINED DITCH BEHIND MĀKAHA VALLEY TOWERS**

During the November 1996 storm, a section of the berm was damaged. Water flow went straight through the berm, and towards the Towers. The berm was repaired after the rain event, which is where the section of the drainage system is lined with concrete to reduce further erosion of the ditch and earth berm.

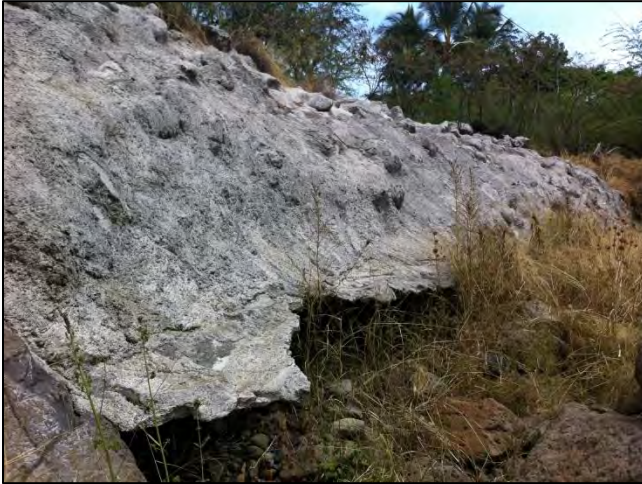
**EARTH BERM ERODING UNDER THE CONCRETE**
