Mākaha Valley Flood Mitigation Study

FINAL REPORT
DECEMBER 2014

Volume I of III

**Department of Land and Natural Resources
Engineering Division**

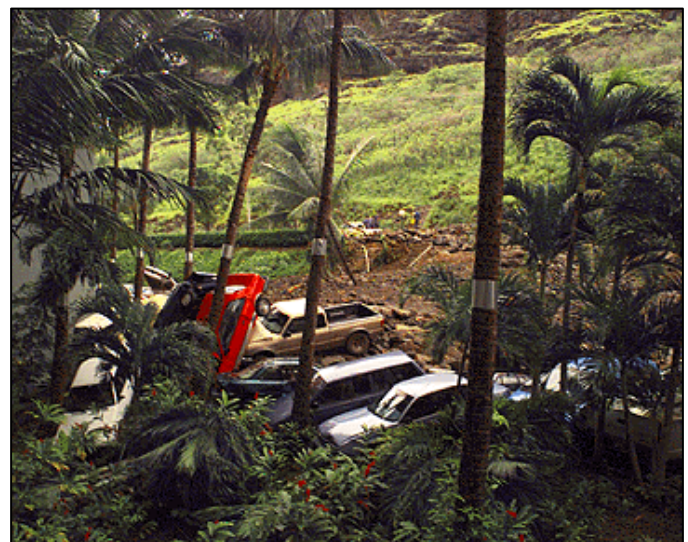
*Car overturned in upper parking lot of Mākaha Valley
Towers after storm in November 1996
Photo Credit: Star-Bulletin*

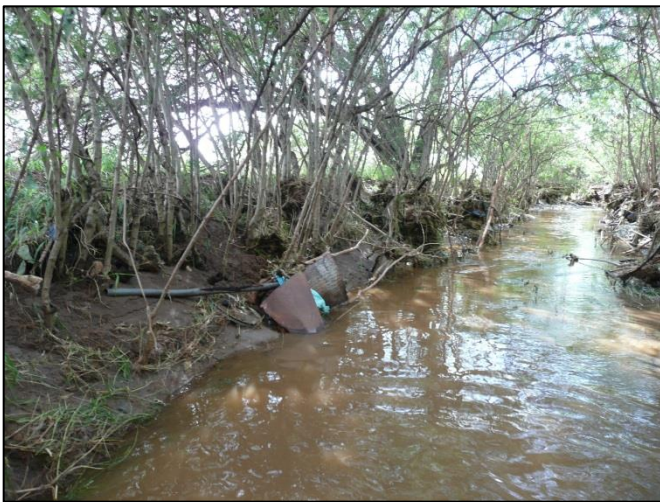
Debris along Eku Stream after December 2008 storm

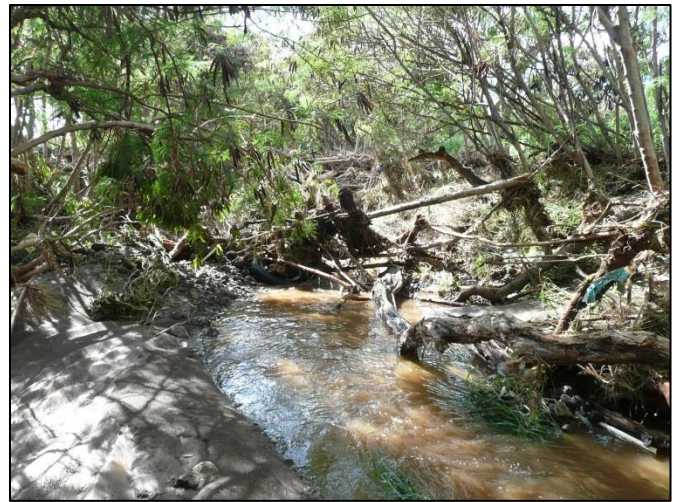
Debris within Eku Stream after December 2008 storm

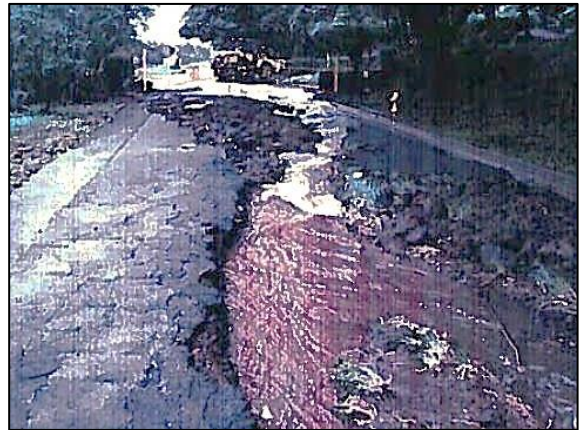
Damages to Kili Drive after January 2011 storm

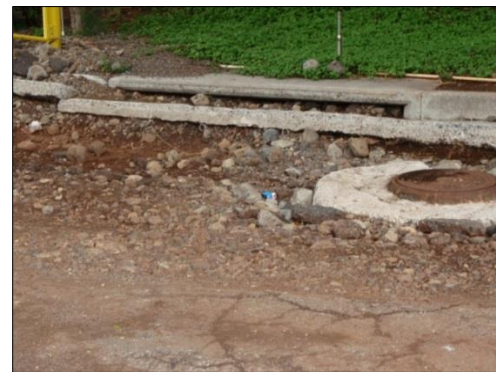
Storm drains are often clogged with small debris and rocks during a storm, which contributes to storm water backup and has resulted in extensive flooding and major road damages. Kili Drive is a private road located on the northern side of Mākaha Valley starting at Farrington Highway and ending near the Mākaha Valley Towers, where it forms an intersection with the Mākaha Valley Towers entrance, Huipu Drive, and an access road to a BWS reservoir. Kili Drive has experienced severe road damages from rocks, debris, and clogged drains that gouge out sections of the pavement. This issue has resulted in extensive flooding of Kili Drive and has closed the road off to residents during storms.

Storm drains clogged with rocks

However, regular storm drain maintenance for both City and privately owned roads is an issue due to budget constraints and manpower. “Adopt-a-Storm Drain” programs can be implemented for Mākaha Valley where volunteers take on the responsibility of removing debris from the storm drains. Cities such as the City of Superior in Wisconsin have successfully incorporated an Adopt-a-Storm Drain Program.

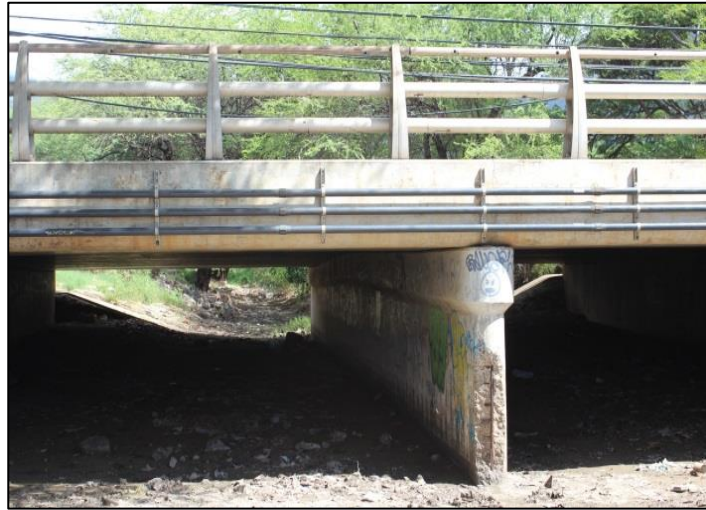
Eku Stream Bridge along Farrington Highway

Construct a new reinforced concrete bridge at Farrington Highway crossing Eku Stream. As-built plans of the existing bridge show that the 100-year peak flow used in the design of the bridge was 2,500 cfs. However, the calculated 100-year peak flow as part of this study that was noted in the previous section for a point just upstream of Farrington Highway is 5,201 cfs. Even with the use of the recommended off-line detention basin, the calculated 100-year peak flow as part of this project was found to be 3,900 cfs, which is 1,400 cfs more than the capacity of the existing bridge for Eku Stream at Farrington Highway. The useful life of a new bridge would be 50 years.

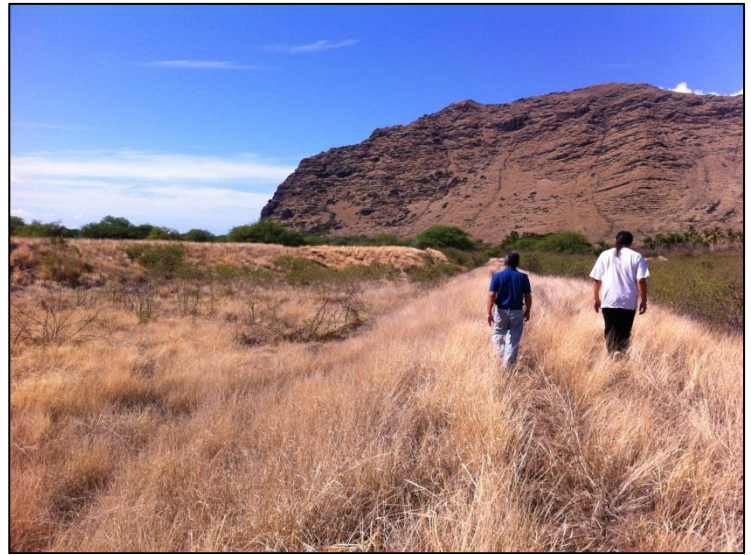
Project team members walk sections of the earthen berm

Repair the earthen berm at the breach, located on Tax Map Key (TMK) 8-4-002:063, with a hard surface such as concrete because the breach is located at a point where the stream makes an abrupt change in direction. This project will return Mākaha Stream to pre-2008 conditions, but should only be considered as a temporary solution. Visual inspection of this berm system revealed that the earthen berms are eroding, and while they may last many more years, other breaks may occur in the future.

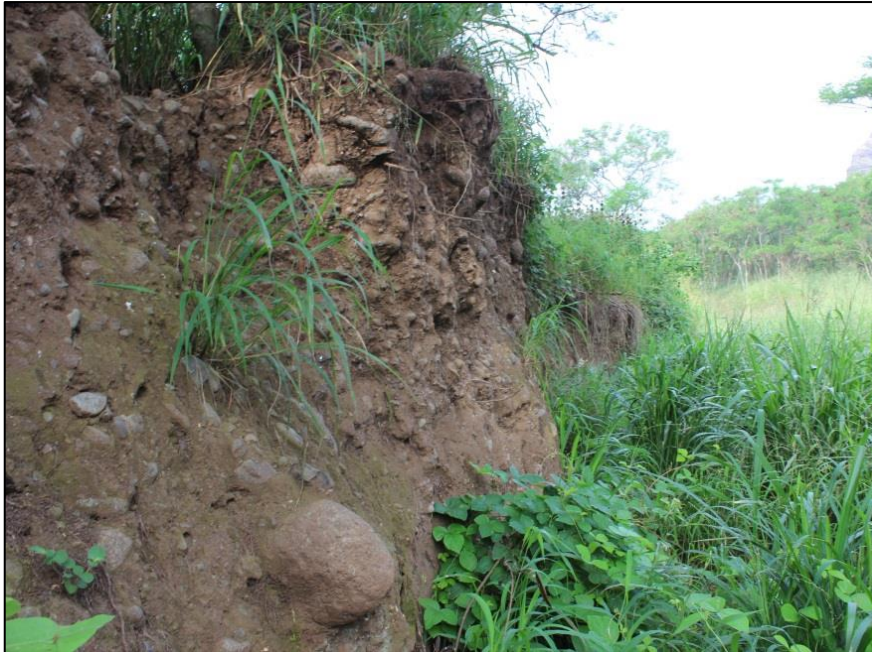
A less costly alternative to constructing the concrete flood wall is to improve the existing earthen berm. The existing Mākaha Stream berm is approximately 12 to 15 feet wide at the top and eight feet high with varying slopes. The slopes vary due to scour and erosion over time. The berm is approximately 2,100 feet in length from the breach in the berm (located on TMK 8-4-002:063) to Farrington Highway. The project team walked sections of the berm, but it was difficult to see the berm in some areas as parts of the berm are no longer there. Sections of the berm will need to be completely reconstructed.

Signs of erosion and scour on the existing earthen berm

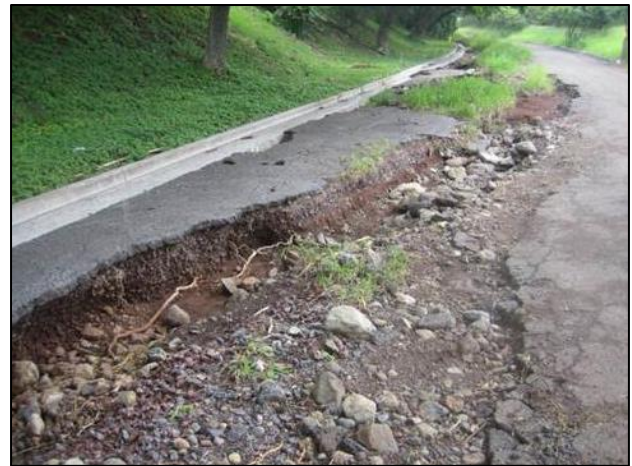
Road damage on the BWS Reservoir Road due to flooding

Construct a trapezoidal shaped, open concrete-lined ditch that is ten feet wide at the base, 24 feet wide at the top of the channel, five feet deep, and with side slopes of 1-vertical to 1-horizontal. The channel will begin at the mauka end of the Mākaha Valley Towers complex and travel along the BWS Reservoir access road and Kili Drive to where West Mākaha Stream crosses Kili Drive at the existing cluster of 30-inch culverts. It may be possible to end the ditch before the West Mākaha Stream crossing, but that is dependent on more detailed survey and study of the area.

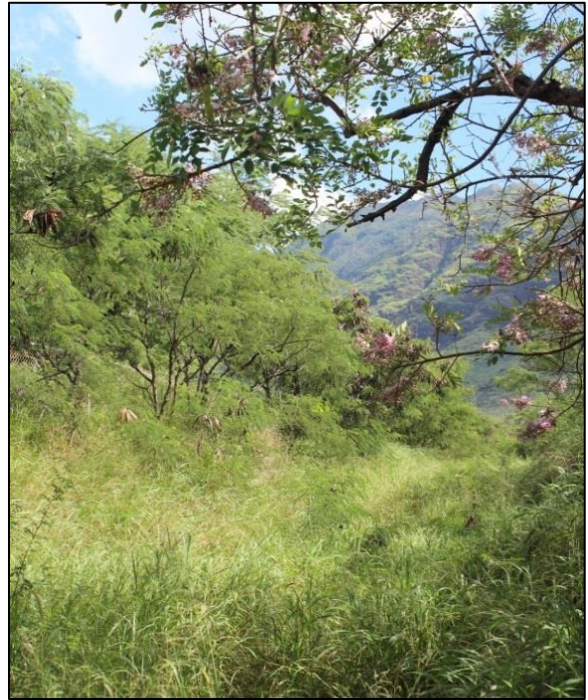
Overgrown vegetation in Eku Stream Channel facing mauka

While the City can enforce regulations requiring stream owners to maintain the stream, a Stream Channel Maintenance Program with regularly scheduled community-wide clean up dates would be more effective.

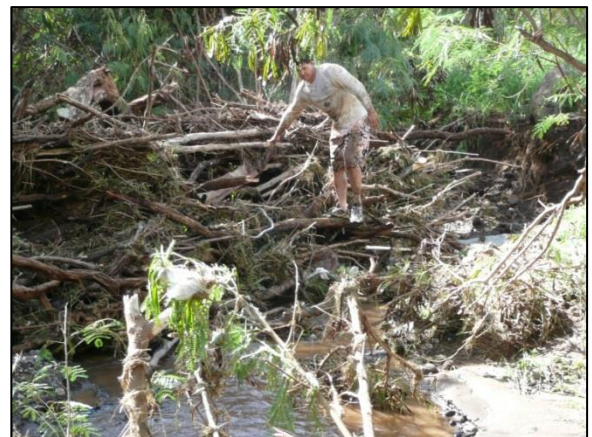
Debris jam in Eku Stream after December 2008 storm

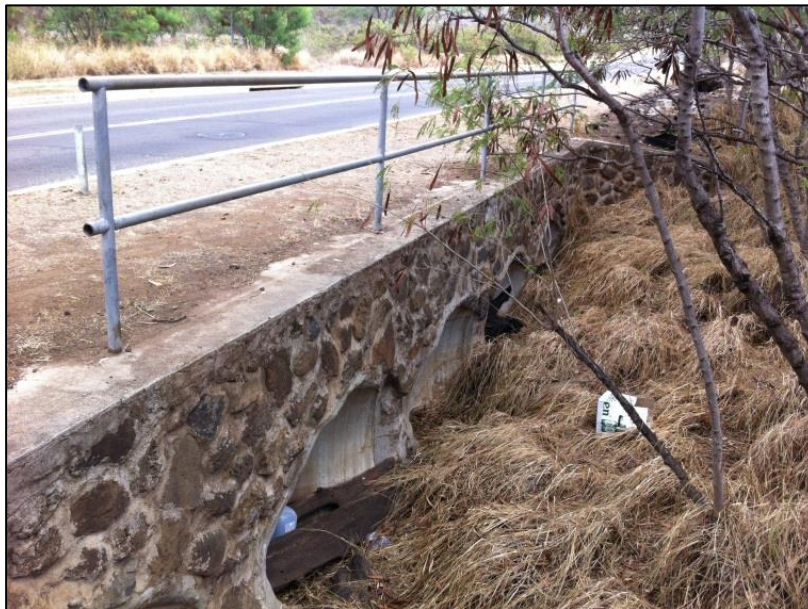
***Debris and litter
along West Mākaha Stream***

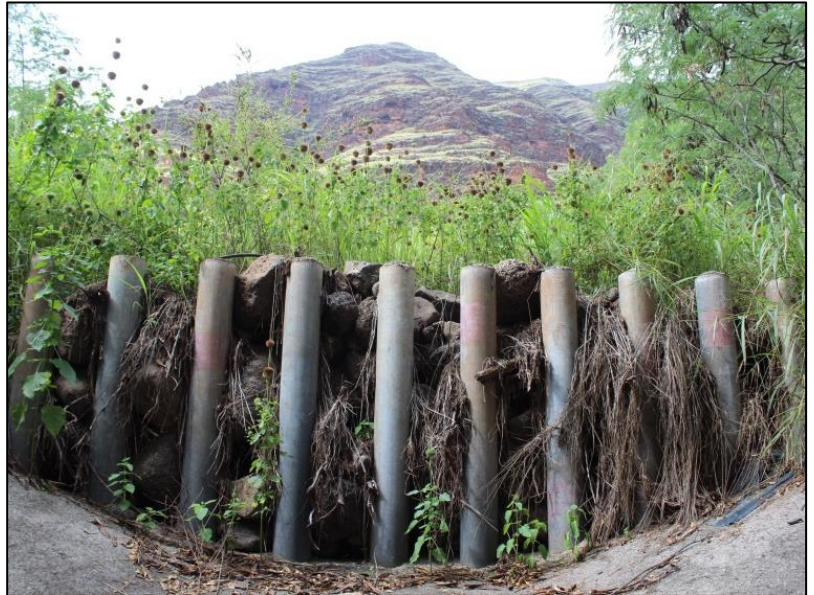
*Three-foot debris poles
filled with rocks to the top*

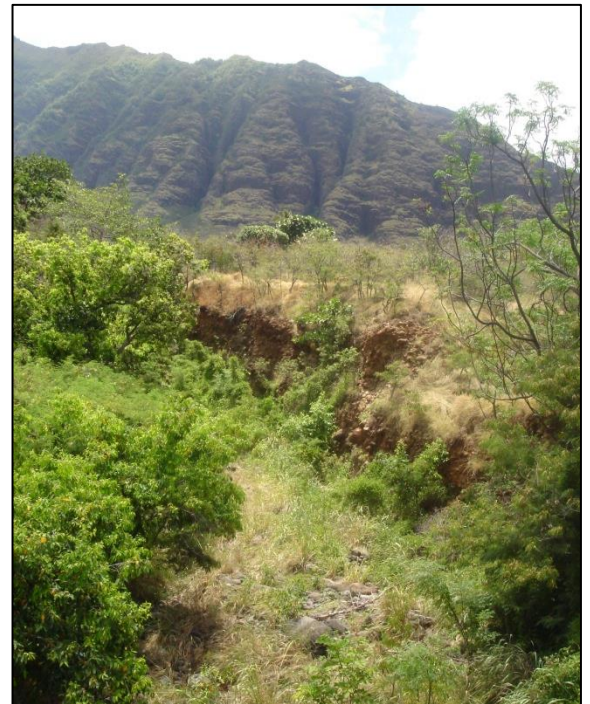
Large trees within Mākaha Stream and eroded stream banks (facing mauka from Huipu Drive)

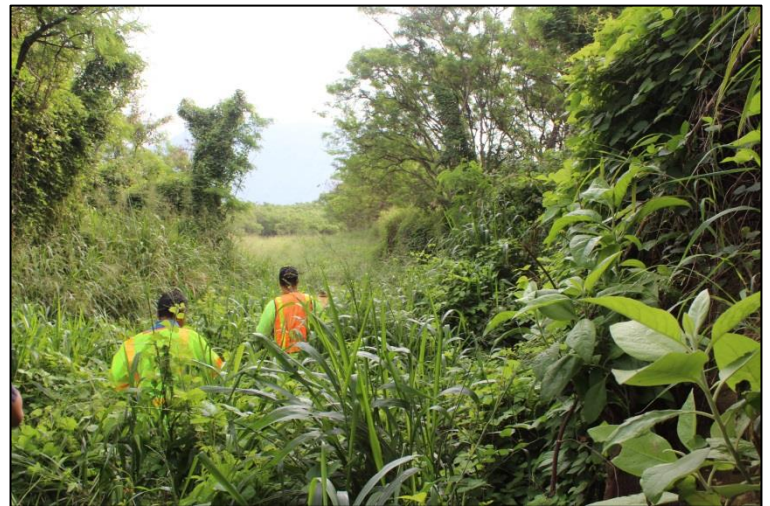
*Lower reaches of Mākaha Stream Channel
overgrown with vegetation
(facing mauka)*

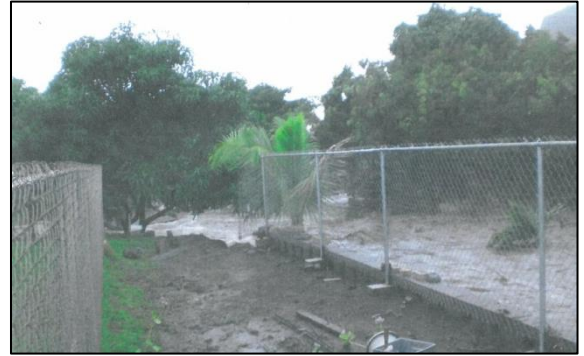
Stormwater flowing behind homes on Manuku Street during December 2008 storm
