# Reconnaissance Level Survey, Kalihiwai Reservoir, Kilauea, Kauai

TMK [4] 5-2-022: 003

Prepared by MASON under contract to  
Gannett Fleming

June 2023

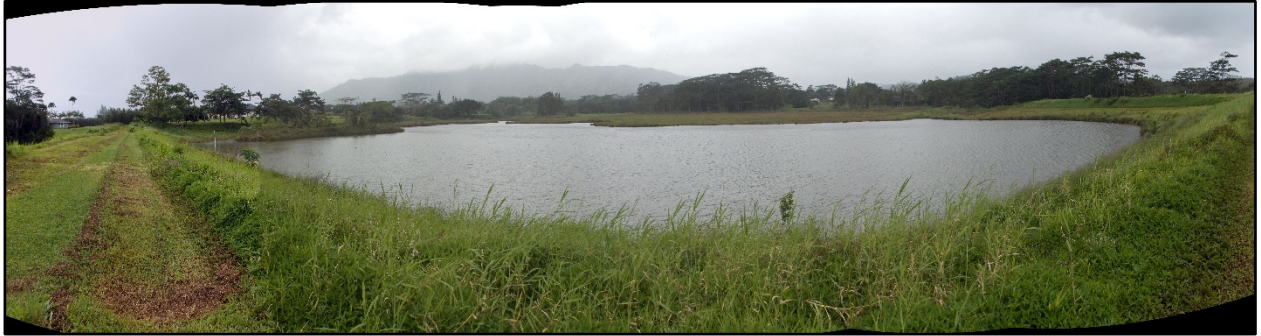
Figure 6: Kalihiwai Reservoir, overview facing south. This composite panorama shows the north section of the L-plan dam on the left, with the west section of the dam extending out to view to the right. *Source: MASON, 2023.*

The reservoir lies at an elevation of about 393' above sea level and just east of Kalihiwai Gulch, about 2 miles south of Kalihiwai Bay. It is impounded by an L-plan earthen dam with a total length of about 1,000' that was built across an unnamed swale. See Figure 4. The dam is about 25' high along the downstream slope, with a hydraulic height of about 17' to 20' on the upstream side. The dam has dense vegetation along the downstream slope and has mown grass on the approximately 15' wide crest, which has a vehicle roadway. The historic, principal spillway is an earthen channel off the west side of the reservoir (southwest of the left embankment) that drains water into Kalihiwai Gulch. This spillway is shallow and wide (approximately 55' wide) as it leaves the reservoir and narrows as it approaches the gulch into a water channel about 15' wide and 10' deep. See Figure 5.

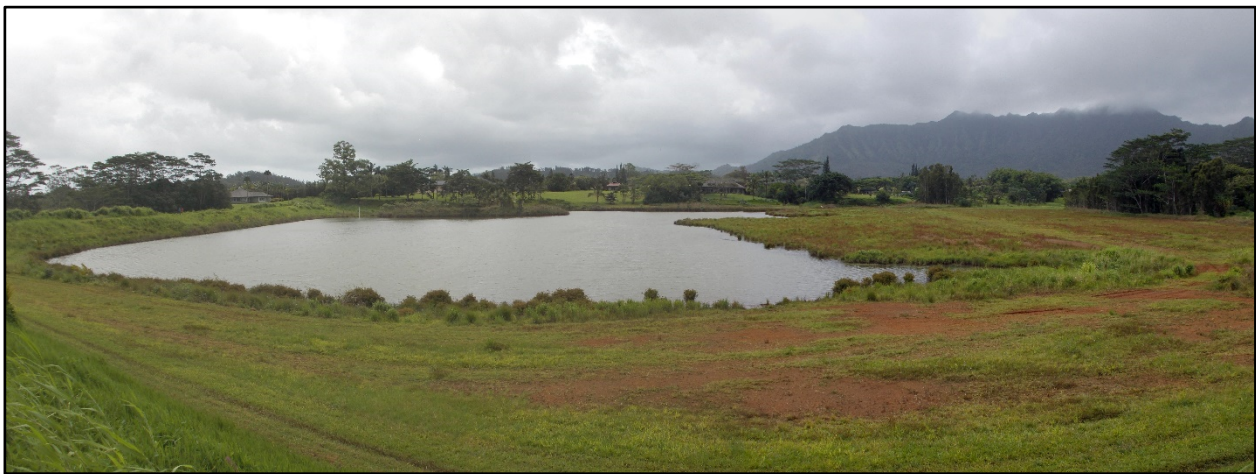
Figure 7: Kalihiwai Reservoir, overview facing southeast. *SOURCE: MASON, 2023.*

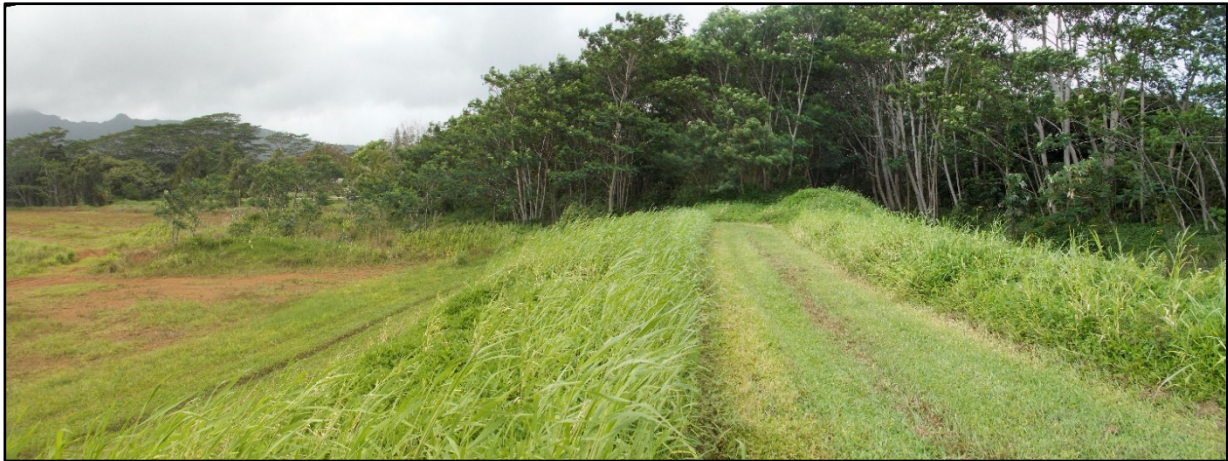
Figure 8: Kalihiwai Reservoir, showing the crest of the dam. View facing southwest. *Source: MASON, 2023.*

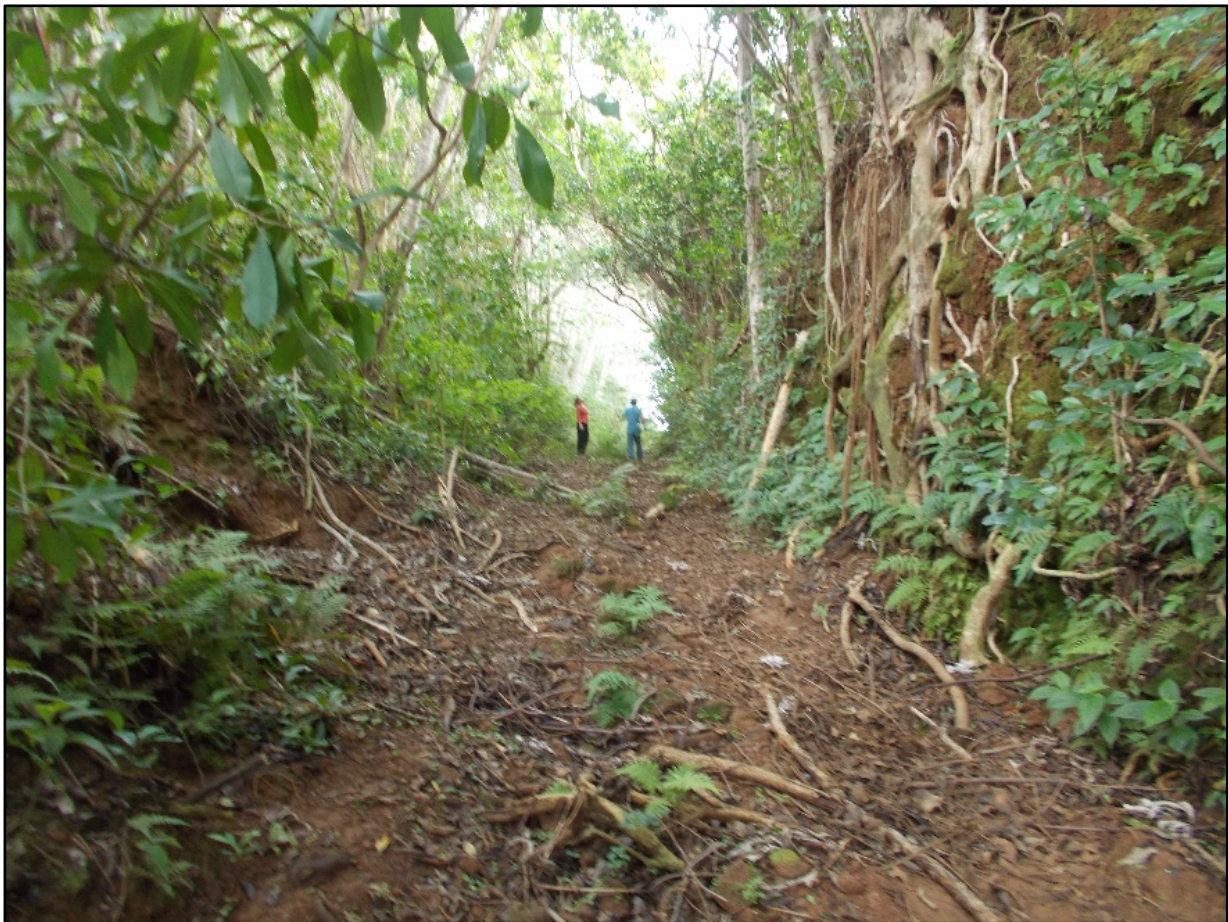
Figure 9. The narrow spillway channel as it approaches Kalihiwai Gulch. View facing east. *Source: MASON, 2023.*

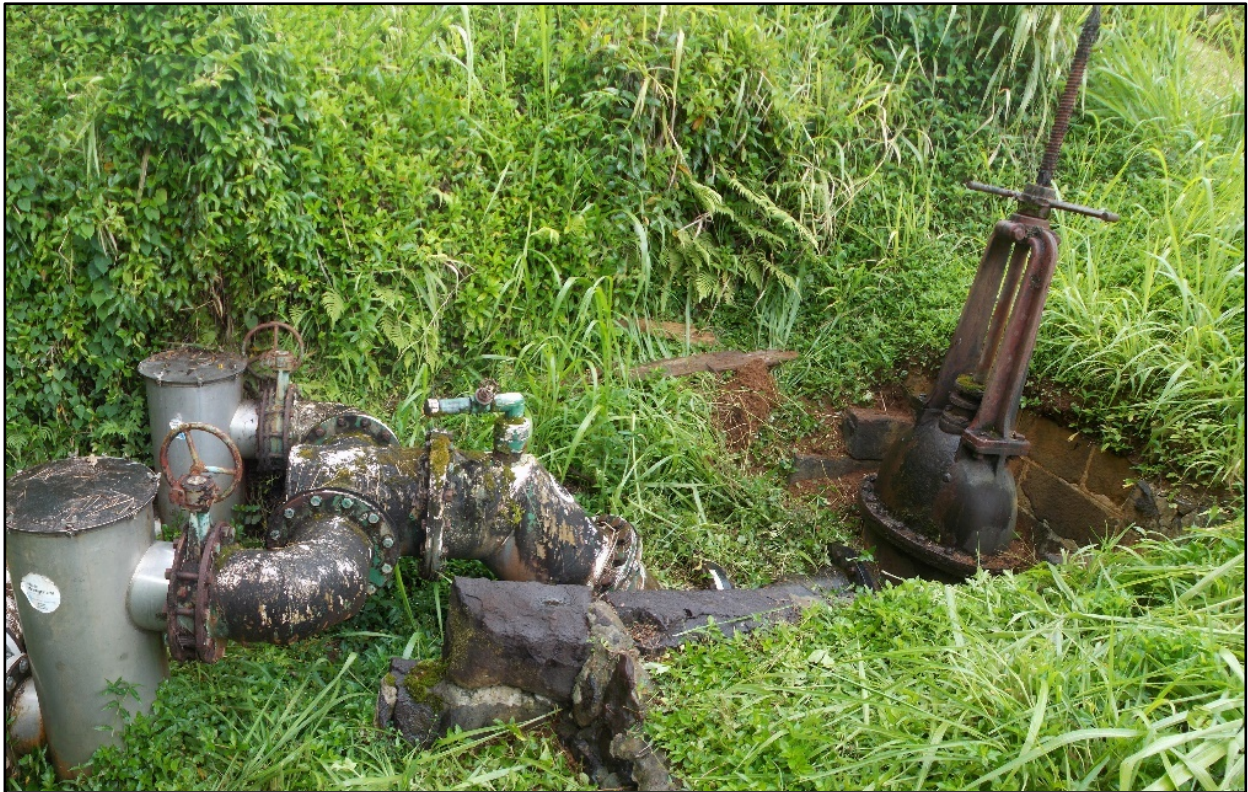
A historic discharge (outlet) is located near the east end of the dam. This is an approximately 24" diameter metal pipe that pierces the dam with its outlet aperture on the downslope face about 18' below the crest. This aperture is stabilized by a masonry section of coursed, quarry-faced ashlar of lava rock with cement mortar that is set against the sloping grade of the embankment. This masonry has a 4' high, 4'6" wide section up against the embankment where the 24" pipe exits the dam. At each side of the 4'6" wide masonry there are perpendicular 9' long wings of similar masonry stabilizing the embankment slope. Within the U-shaped plan of this masonry, the discharge pipe has a large metal gate valve. See Figure 7. Down-flow of this valve, the discharge pipe is reduced to 18" diameter before T-ing into two 12" pipes that are run

into vertical filter units that contain stainless steel screening to filter the water. The outlets from the two filters are then T-ed back into a single 18" steel pipe that is routed downslope. It is not known if water from the reservoir is flowing through this discharge piping. The inlet of this discharge piping is under the reservoir's water level and was not observable.

Figure 10. The historic outlet aperture is stabilized by coursed, quarry-faced lava rock masonry. Note the large metal gate valve at the right and the metal piping with two filters extending to the left from the gate valve. View facing southeast. *Source: MASON, 2023.*

- In 2018 the historic concrete headwall of the main inlet from Hanalei Ditch was removed during a heavy rain event and replaced with an outlet of two large diameter PVC culvert pipes.
- At an unknown date two water filters were installed at the large diameter metal piping of the historic reservoir outlet.
