Mākaha Valley Flood Mitigation Study

PUBLIC REVIEW DRAFT REPORT
SEPTEMBER 2014

Volume I of III

**Department of Land and Natural Resources
Engineering Division**

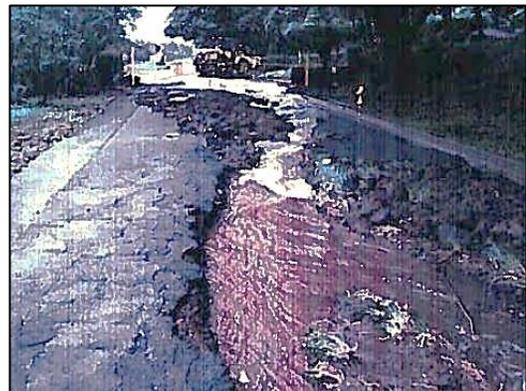
Damages to Kili Drive after January 2011 storm

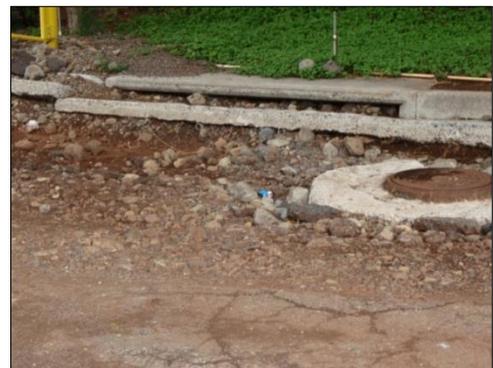
Storm drains are often clogged with small debris and rocks during a storm, which contributes to storm water backup and has resulted in extensive flooding and major road damages. Kili Drive is a private road located on the northern side of Mākaha Valley starting at Farrington Highway and ending near the Mākaha Valley Towers, where it forms an intersection with the Mākaha Valley Towers entrance, Huipu Drive, and an access road to a BWS reservoir. Kili Drive has experienced severe road damages from rocks, debris, and clogged drains that gouge out sections of the pavement. This issue has resulted in extensive flooding of Kili Drive and has closed the road off to residents during storms.

Storm drains clogged with rocks

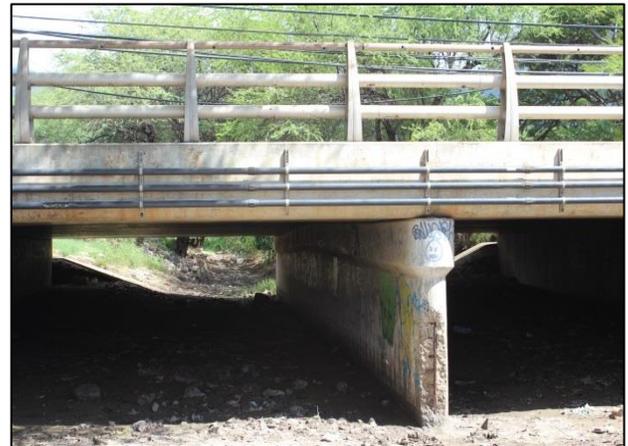
Construct a new reinforced concrete bridge at Farrington Highway crossing Eku Stream. As-built plans of the existing bridge show that the 100-year peak flow used in the design of the bridge was 2,500 cfs. However, the calculated 100-year peak flow as part of this study that was noted in the previous section for a point just upstream of Farrington Highway is 5,201 cfs. Even with the use of the recommended off-line detention basin, the calculated 100-year peak flow as part of this project was found to be 3,900 cfs, which is a difference of 1,400 cfs from the capacity of the existing bridge for Eku Stream at Farrington Highway. The useful life of a new bridge would be 50 years.

Existing Eku Stream Bridge

Similarly, properties located near the mouth of Eku Stream are exposed to higher flood risk due to storm water that is constricted by Eku Stream Bridge. This bridge was built in 1989 and is inadequately sized to accommodate flows for a 100-year storm. Storm water that is constricted at the bridge may contribute to flooding of adjacent properties near the bridge.

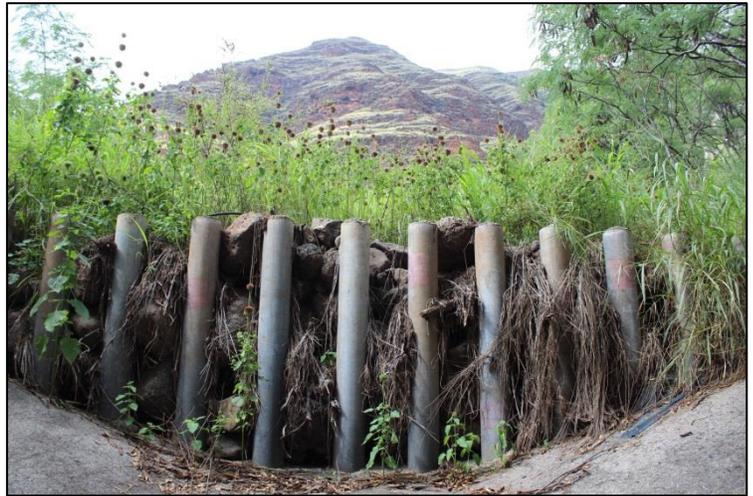
*Three-foot debris poles
filled with rocks to the top*
